# Richmond Refinery LPS Bulletin – Reliability

## Inter-Reactor Quench Exchanger Temperature Swing Gasket Leak

Hydroprocessing Division,  
RLOP - Heavy Neutral  
Cracker (HNC)

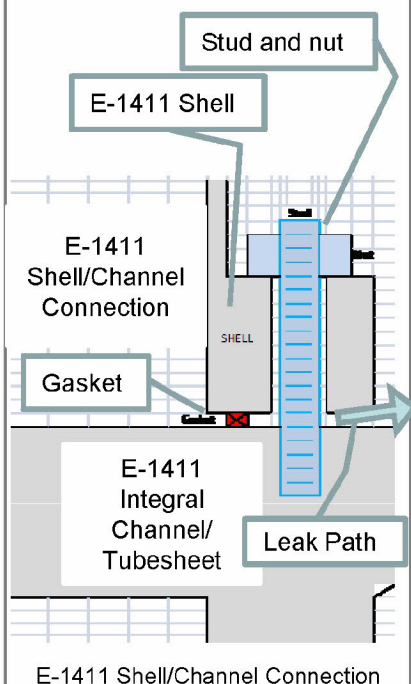
At 12:30 pm on April 26, 2012, the HNC startup was delayed when the E-1411 Inter-Reactor Quench Exchanger began to leak at the channel-to-shell connection. This leak occurred about 12 hours after an unplanned HNC shutdown due to a cable failure of the Recycle H2 Compressor Turbine TK-1400 thrust monitoring system. (Refer to Loss # 36434 and TapRoot Investigation # 22505.) Operations responded quickly by discontinuing the HNC startup, but the leak continued. Maintenance responded by hot-torquing the exchanger head, installed new nuts, and reestablished the torque on the E-1411 channel-to-shell connection.

- 1) Loss of recycle flow at HNC resulted in implementation of emergency shutdown procedures which caused a rapid temperature drop on the E-1411 shell-side relative to the hot tube-side inlet temperature.
- 2) E-1411 is susceptible to low gasket stress and subsequent leakage if the exchanger shell is cooled substantially and rapidly relative to the channel section.

- 1) Initial gasket stress was greatly reduced due to the manner in which the unit is operated during the emergency shutdown.
- 2) Allowances for the dynamic loading and unequal heat distribution as part of the emergency shutdown procedures were not included in the closure design calculations for this exchanger.

- 1) Develop a new gasket closure procedure that can withstand unexpected thermal gradients during unplanned emergency HNC shutdowns.
- 2) Implement hot torquing of E-1411 with the new gasket closure procedure developed by the Design Engineering Department at the next available opportunity.
- 3) Design Engineering to review other heat exchanger units in similar service where significant process induced temperature swings could effect gasket stress to verify that current torquing procedures are adequate.
- 4) Review engineering procedures and guidance for establishing flange closure calculations. Specifically review the adequacy in addressing alternate (non-steady state) load cases.
